SUBGRADE STABILIZATION, GAINESVILLE, FLORIDA, USA

Constructing hurricane-proof roads in flood prone areas with MIRAFI

Industry: Transportation
Application: Subgrade Stabilization
Location: Gainesville, Florida, USA
Product: **MIRAFI® RS580i**

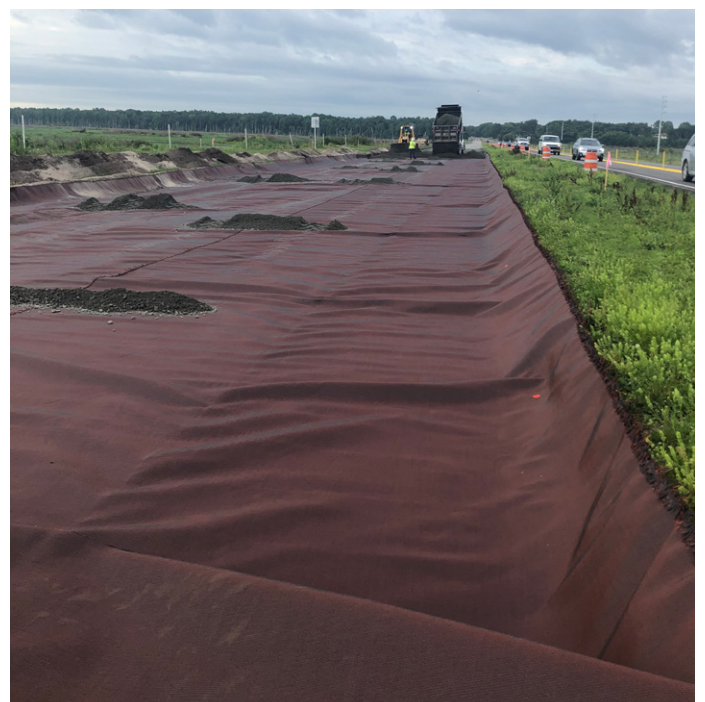
Since reopening, the highway has endured multiple hurricanes and flood events, without requiring maintenance or repair.

The design for the reconstructed roadway consisted of removing the existing asphalt and roadway base, with 105,000 yd² (87,793 m²) **MIRAFI RS580i** placed directly on the exposed subgrade. No other subgrade stabilization methods were used. After the placement of the **MIRAFI RS580i**, 11 in (28 cm) of graded aggregate base was placed and compacted. The final step in the design involved placing the asphalt.

The reconstruction was completed in December 2021. Since reopening, the highway has endured multiple hurricanes and flood events. The high flow rate of **MIRAFI RS580i** and its ability to provide separation, has prevented fines and organics from contaminating the roadway base. The roadway continues to perform well without requiring maintenance or repair. To date, this is the largest FDOT installation of the RS*i* material.
