PUBLIC POWER AND IRRIGATION, LAKE MCCONAUGHY, NEBRASKA

Protecting shorelines from erosion

Industry: Residential Infrastructure
Application: Erosion protection
Location: Lake McConaughy, Ogalla, Nebraska

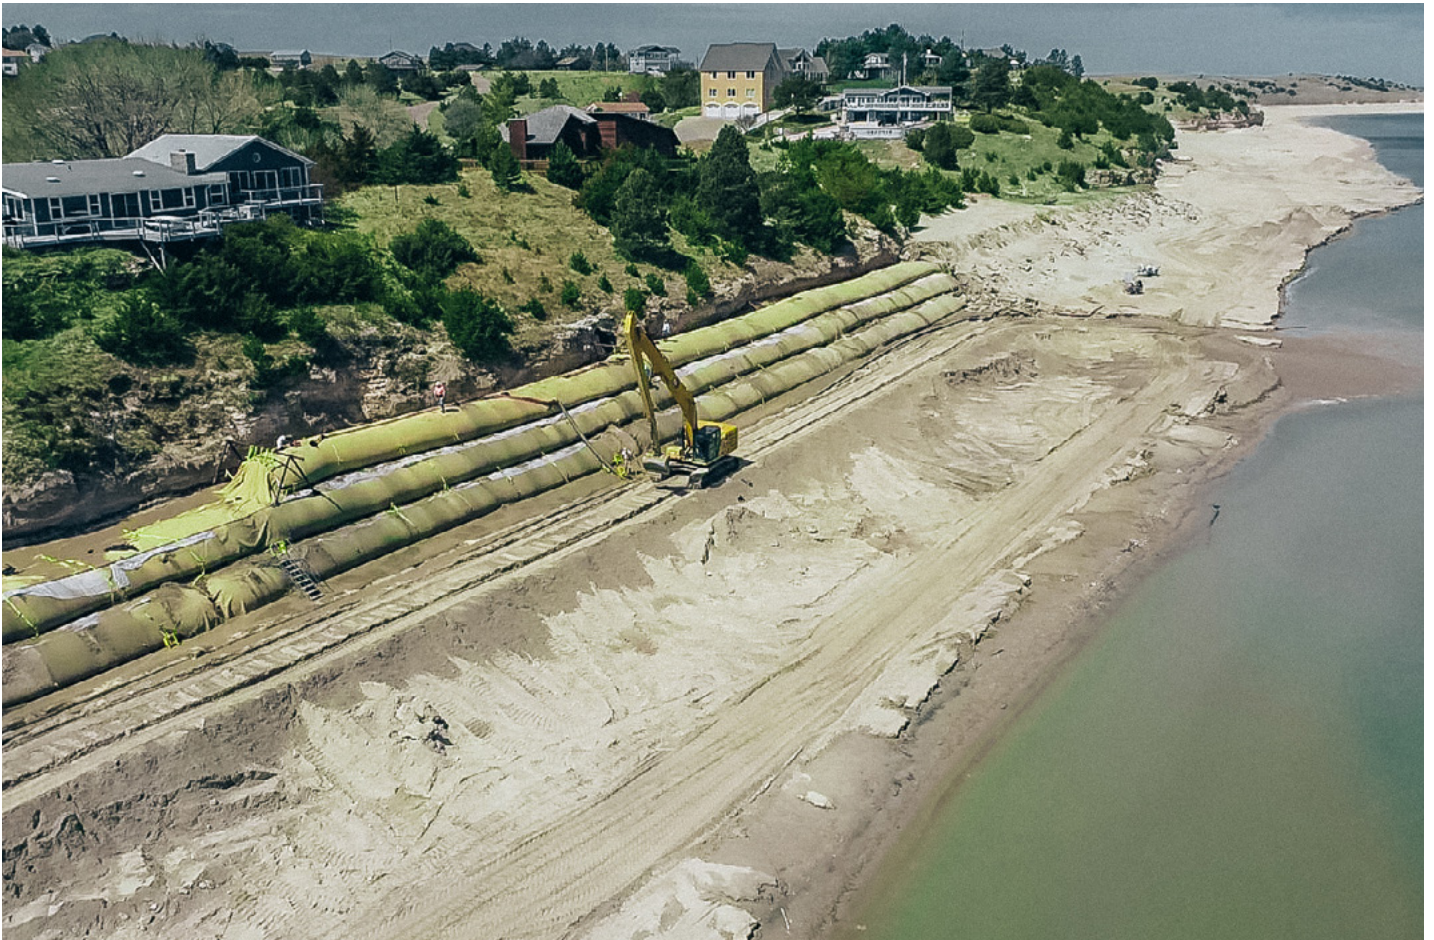
Three layers of 9 m (30 ft) geotextile-tube units were installed to protect 174 m (572 ft) of shoreline. This project successfully stabilized the shoreline along the cliff, protecting at least three homes from collapsing into the lake.

Each layer was a minimum of 9 m (30 ft) in circumference and filled with a pumped sand slurry to a minimum of 1.7 m (5.5 ft) high. The tubes were fabricated with flat ends to achieve a continuous level top surface of each level.
